FAILURE DESCRIPTION AND ANALYSIS

FINDING THE ROOT CAUSE

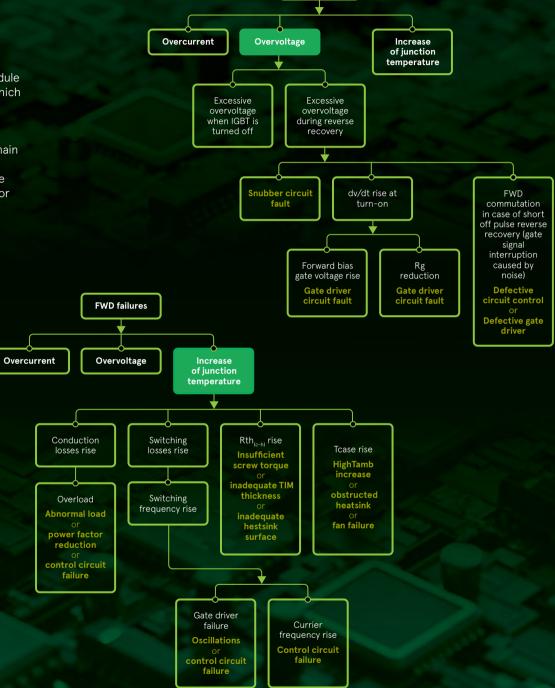
Figure 8

Failures caused by overvoltage at the free-wheeling diode (FWD)

Sudden increase in Tj on the FWD can be a final area to look at as highlighted in Fig. 8.
