FAILURE DESCRIPTION AND ANALYSIS

FINDING THE ROOT CAUSE

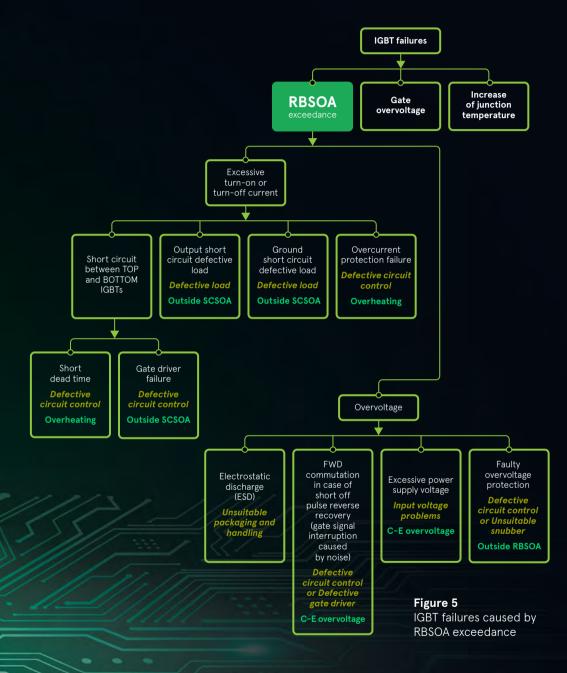
Looking at the IGBT, the first area to consider is the Reverse Bias Safe Operation Area (RBSOA) illustrated in Fig. 5, which is usually described as a range of Vce and Ic under which the module can be operated without concern. The corresponding graph is typically described in the module data sheet.
